**Flood Control Project Maintenance
Levee Inspections**

Maintenance Issue Types Only, Levee Inspection Report By Mile - Spring 2016

Butte County Department of Public Works

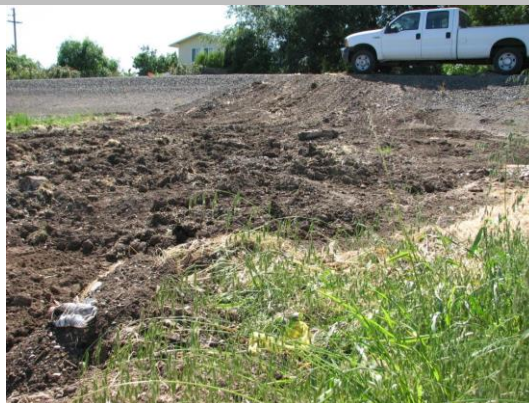
Photo 1 of 2 : SP_2016_NA0003_64_41_20160506_00051.jpg

LM Start	2.06	Rating **	M	Issue No.	41
LM End	2.06	Issue Type +	Ma	Location *	WS
Category	Earthen Levee			GPS Latitude/Longitude	
				Start	End
Item	Slope Stability			39.749149 °	39.749149 °
				-121.918510 °	-121.918510 °
DWR ID	DWR_NA0003_01_s _ 2016_41				
Comment Code					
S3 : Repair the levee slope damaged by vehicle traffic and prevent access where possible.					
Inspector Comment					
Homeowner is dragging soil and debris across levee and dumping on waterside terrace.

04/25/2016: Soil and debris dragged across levee from L/S to W/S.

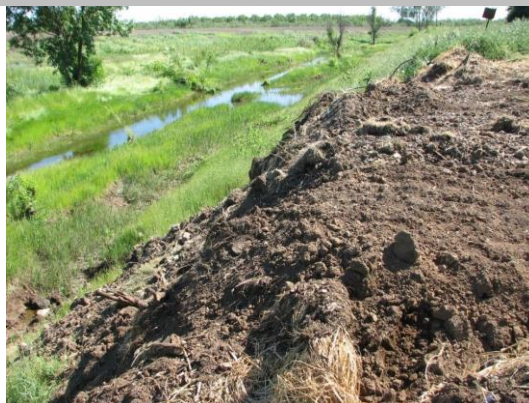
Photo 2 of 2 : SP_2016_NA0003_64_41_20160506_00053.jpg

04/25/2016: Soil and debris dragged across levee from L/S to W/S and pushed into channel.

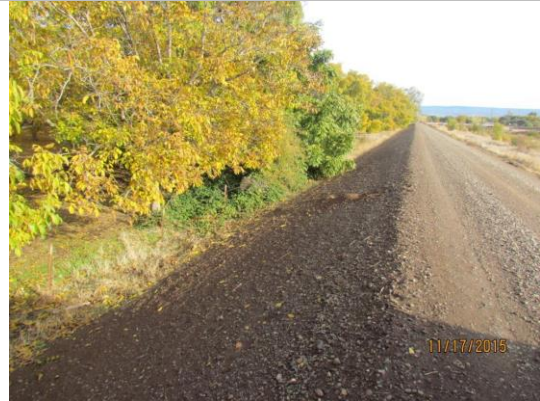
Photo 1 of 1 : SP_2016_NA0003_64_33_20160321_00015.jpg

LM Start	4.27	Rating **	M	Issue No.	33
LM End	4.27	Issue Type +	Ma	Location *	LS
Category	Earthen Levee			GPS Latitude/Longitude	
				Start	End
Item	Animal Control			39.773398 °	39.773398 °
				-121.895765 °	-121.895765 °
DWR ID	DWR_NA0003_01_f_2015_33				
Comment Code					
A1 : Exterminate rodents and backfill and compact or grout burrows.					
Inspector Comment					
Repair the rodent holes along the landside slope.

View of the rodent holes along the landside slope.

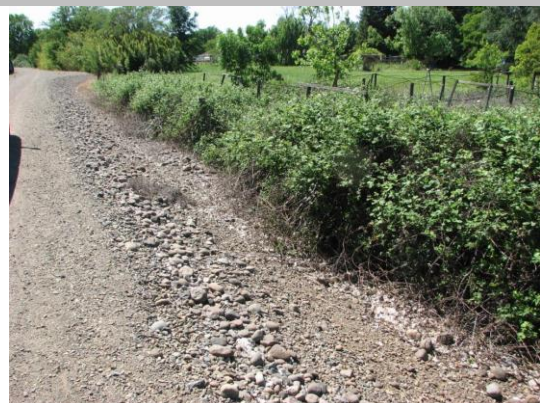
Photo 1 of 1 : SP_2016_NA0003_64_34_20160506_00043.jpg

LM Start	6.16	Rating **	M	Issue No.	34
LM End	6.16	Issue Type +	Ma	Location *	LS
Category	Earthen Levee			GPS Latitude/Longitude	
				Start	End
Item	Vegetation			39.795428 °	39.795428 °
				-121.885306 °	-121.885306 °
DWR ID	DWR_NA0003_01_s_2016_34				
Comment Code					
V2 : Remove the wild growth other than native grasses from the levee slopes.					
Inspector Comment					
Blackberry bramble on landside toe blocking visibility.

04/25/2016: Trim vegetation at L/S toe.

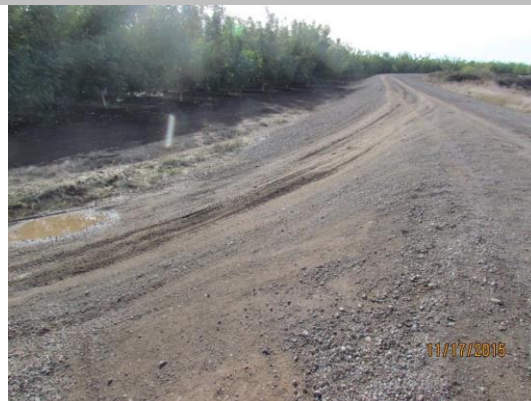
Photo 1 of 1 : SP_2016_NA0003_65_10_20160321_00006.jpg

LM Start	3.52	Rating **	M	Issue No.	10
LM End	3.52	Issue Type +	Ma	Location *	LS
Category	Earthen Levee			GPS Latitude/Longitude	
				Start	End
Item	Slope Stability			39.760582 °	39.760582 °
				-121.910303 °	-121.910303 °
DWR ID	DWR_NA0003_02_f_2015_10				
Comment Code					
S3 : Repair the levee slope damaged by vehicle traffic and prevent access where possible.					
Inspector Comment					
Repair the vehicle erosion along the landside slope.

View of the vehicle erosion along the landside slope.

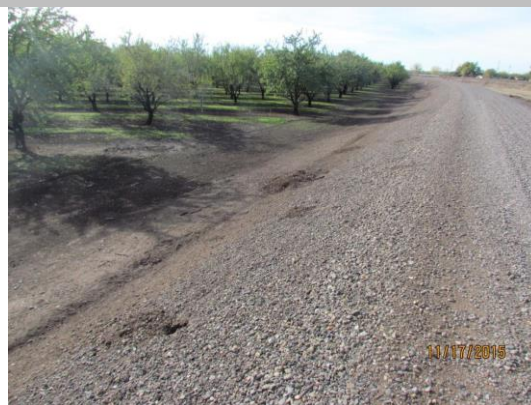
Photo 1 of 1 : SP_2016_NA0003_65_11_20160321_00007.jpg

LM Start	4.42	Rating **	M	Issue No.	11
LM End	4.42	Issue Type +	Ma	Location *	LS
Category	Earthen Levee			GPS Latitude/Longitude	
				Start	End
Item	Animal Control			39.751120 °	39.751120 °
				-121.915977 °	-121.915977 °
DWR ID	DWR_NA0003_02_f_2015_11				
Comment Code					
A3 : No rodents visible, but rodent burrows visible; need to backfill and compact or grout burrows.					
Inspector Comment					
Repair the rodent holes along the landside slope.

View of the rodent holes along the landside slope.

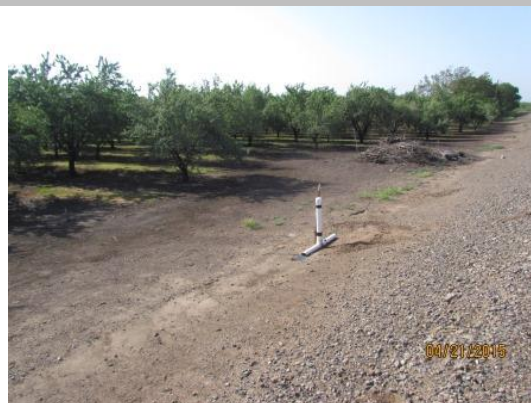
Photo 1 of 2 : SP_2016_NA0003_65_8_20160321_00004.jpg

LM Start	4.55	Rating **	A/W	Issue No.	8
LM End	4.55	Issue Type +	Ma	Location *	LS
Category	Earthen Levee			GPS Latitude/Longitude	
				Start	End
Item	Animal Control			39.749639 °	39.749639 °
				-121.917188 °	-121.917188 °
DWR ID	DWR_NA0003_02_f_2013_8				
Comment Code					
A1 : Exterminate rodents and backfill and compact or grout burrows.					
Inspector Comment					
Butte County has been grouting the rodent holes.

View of the bait station placed by the rodent hole.

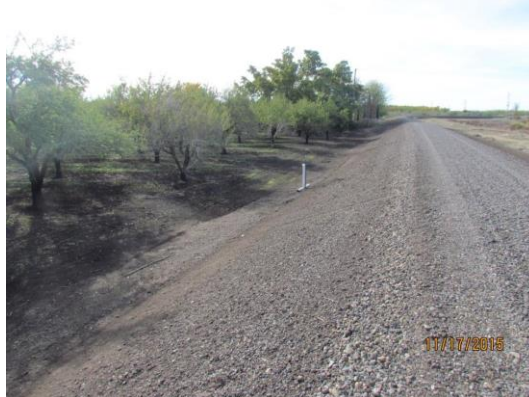
Photo 2 of 2 : SP_2016_NA0003_65_8_20160321_00005.jpg

LM Start	4.55	Rating **	A/W	Issue No.	8 (cont)	
LM End	4.55	Issue Type +	Ma	Location *	LS	
Category	Earthen Levee			GPS Latitude/Longitude		
				Start		End
Item	Animal Control			39.749639 °		39.749639 °
				-121.917188 °		-121.917188 °
DWR ID	DWR_NA0003_02_f_2013_8					
Comment Code						
A1 : Exterminate rodents and backfill and compact or grout burrows.						
Inspector Comment						
Butte County has been grouting the rodent holes.

View of the bait station by the rodent holes.

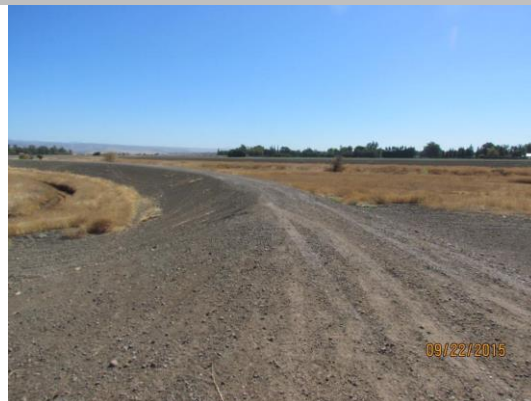
Photo 1 of 1 : SP_2016_NA0003_67_12_20160321_00002.jpg

LM Start	0.02	Rating **	M	Issue No.	12
LM End	0.02	Issue Type +	Ma	Location *	LS
Category	Earthen Levee			GPS Latitude/Longitude	
				Start	End
Item	Slope Stability			39.785970 °	39.785970 °
				-121.882797 °	-121.882797 °
DWR ID	DWR_NA0003_03_f_2015_12				
Comment Code					
S3 : Repair the levee slope damaged by vehicle traffic and prevent access where possible.					
Inspector Comment					
Repair the erosion on both slopes caused by motorcycle traffic.

View of the erosion on both slopes caused by motorcycle traffic.

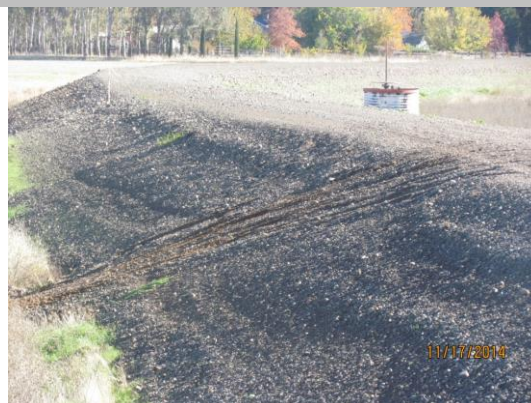
Photo 1 of 1 : SP_2016_NA0003_67_3_20160321_00001.jpg

LM Start	0.07	Rating **	M	Issue No.	3
LM End	0.07	Issue Type +	Ma	Location *	WS
Category	Earthen Levee			GPS Latitude/Longitude	
				Start	End
Item	Slope Stability			39.786068 °	39.786068 °
				-121.881828 °	-121.881828 °
DWR ID	DWR_NA0003_03_s_2012_3				
Comment Code					
S3 : Repair the levee slope damaged by vehicle traffic and prevent access where possible.					
Inspector Comment					
Repair the erosion on landside slope caused by motorcycle traffic.

View of the erosion caused by motorcycles on the land side slope.

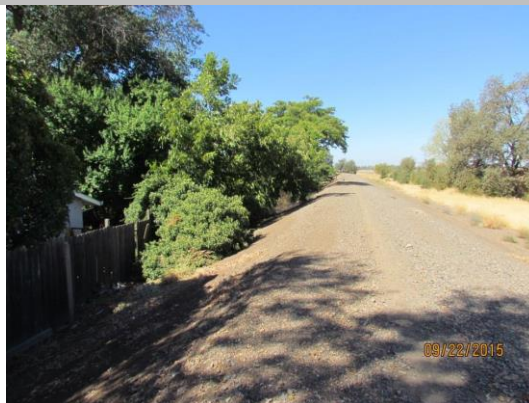
Photo 1 of 1 : SP_2016_NA0003_68_17_20160321_00004.jpg

LM Start	1.16	Rating **	M	Issue No.	17
LM End	1.22	Issue Type +	Ma	Location *	LS
Category	Earthen Levee			GPS Latitude/Longitude	
				Start	End
Item	Trim / Thin Trees			39.777128 °	39.777580 °
				-121.854763 °	-121.855612 °
DWR ID	DWR_NA0003_04_f_2015_17				
Comment Code					
T1 : Trim trees to at least five feet above ground level.					
Inspector Comment					
Remove the trees that are overhanging the levee slope.

View of the trees overhanging the levee slope.

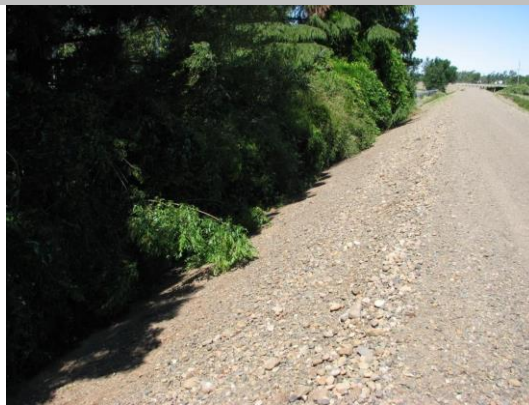
Photo 1 of 1 : SP_2016_NA0003_68_18_20160506_00035.jpg

LM Start	2.04	Rating **	U	Issue No.	18
LM End	2.08	Issue Type +	Ma	Location *	LS
Category	Earthen Levee			GPS Latitude/Longitude	
				Start	End
Item	Trim / Thin Trees			39.781669 °	39.782025 °
				-121.869804 °	-121.870252 °
DWR ID	DWR_NA0003_04_s_2016_18				
Comment Code					
T2 : Thin trees to allow visibility of the ground and room to flood fight.					
Inspector Comment					
Trees and shrubbery obscure visibility on landside toe hinge point.

04/25/2016: Trim vegetation on fence at L/S toe.

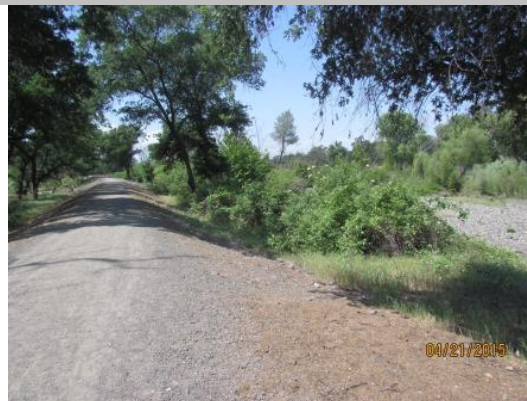
Photo 1 of 2 : SP_2016_NA0003_69_4_20160321_00003.jpg

LM Start	0.21	Rating **	M	Issue No.	4
LM End	0.26	Issue Type +	Ma	Location *	WS
Category	Earthen Levee			GPS Latitude/Longitude	
				Start	End
Item	Vegetation			39.761957 °	39.761892 °
				-121.792867 °	-121.793705 °
DWR ID	DWR_NA0003_05_f_2014_4				
Comment Code					
V2 : Remove the wild growth other than native grasses from the levee slopes.					
Inspector Comment					
Remove the vegetation from the waterside slope.

View of the vegetation along the waterside slope.

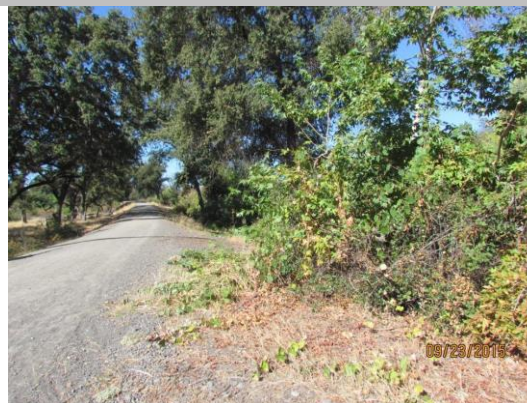
Photo 2 of 2 : SP_2016_NA0003_69_4_20160321_00004.jpg

View of the vegetation along the waterside slope.

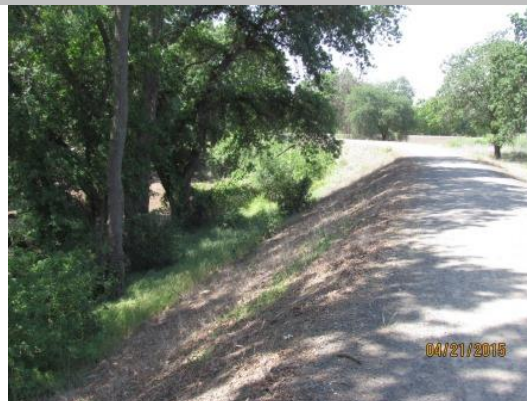
Photo 1 of 2 : SP_2016_NA0003_69_3_20160321_00001.jpg

LM Start	0.34	Rating **	M	Issue No.	3
LM End	0.42	Issue Type +	Ma	Location *	LS
Category	Earthen Levee			GPS Latitude/Longitude	
				Start	End
Item	Vegetation			39.761633 °	39.761117 °
				-121.795155 °	-121.796464 °
DWR ID	DWR_NA0003_05_f_2013_3				
Comment Code					
V2 : Remove the wild growth other than native grasses from the levee slopes.					
Inspector Comment					
Remove the vegetation from the landside slope and toe.

View of the vegetation along the landside slope and toe

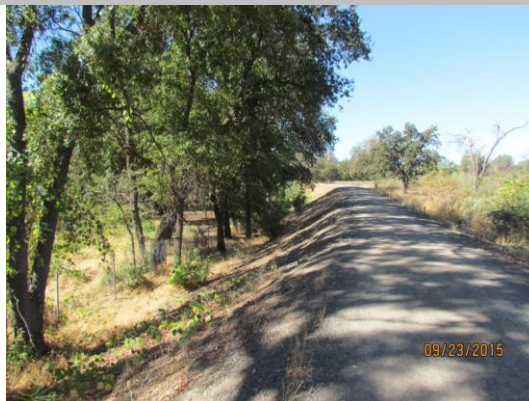
Photo 2 of 2 : SP_2016_NA0003_69_3_20160321_00002.jpg

LM Start	0.34	Rating **	M	Issue No.	3 (cont)	
LM End	0.42	Issue Type +	Ma	Location *	LS	
Category	Earthen Levee			GPS Latitude/Longitude		
				Start		End
Item	Vegetation			39.761633 °		39.761117 °
				-121.795155 °		-121.796464 °
DWR ID	DWR_NA0003_05_f_2013_3					
Comment Code						
V2 : Remove the wild growth other than native grasses from the levee slopes.						
Inspector Comment						
Remove the vegetation from the landside slope and toe.

View of the vegetation along the landside slope and toe.

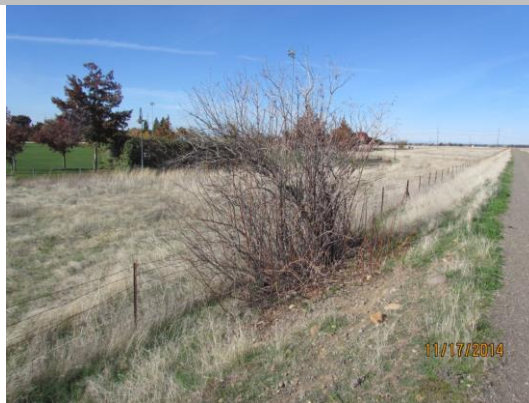
Photo 1 of 1 : SP_2016_NA0003_69_6_20160321_00005.jpg

LM Start	0.89	Rating **	A/W	Issue No.	6
LM End	0.89	Issue Type +	Ma	Location *	LS
Category	Earthen Levee			GPS Latitude/Longitude	
				Start	End
Item	Vegetation			39.764397 °	39.764397 °
				-121.803335 °	-121.803335 °
DWR ID	DWR_NA0003_05_f_2014_6				
Comment Code					
V4 : Elderberries are blocking visibility and flood fight capability.					
Inspector Comment					
Elderberry is not completely blocking the visibility.

View of the elderberry along the landside toe.
